RCRA/VRP REMEDIATION SITE

Opelika, AL

Soil Blending-
CHP/Persulfate

NFA Pending

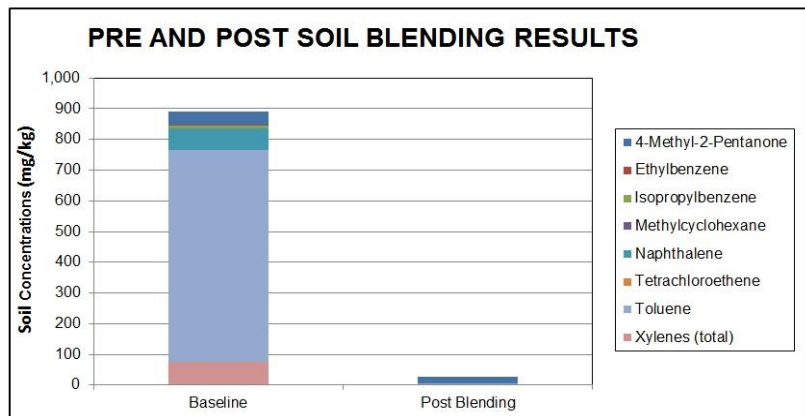
□ Field test kits were utilized during blending to track progress. Confirmatory soil samples indicated total VOC concentrations were below risk based target treatment goals (see graph). A NFA is pending.
